Technical Report GL-93-20  
August 1993

## **Effects of Variable Tire Pressure on Road Surfacing**

### **Volume I: Design, Construction, Behavior Under Traffic, and Test Results**

*by Robert W. Grau  
Geotechnical Laboratory*

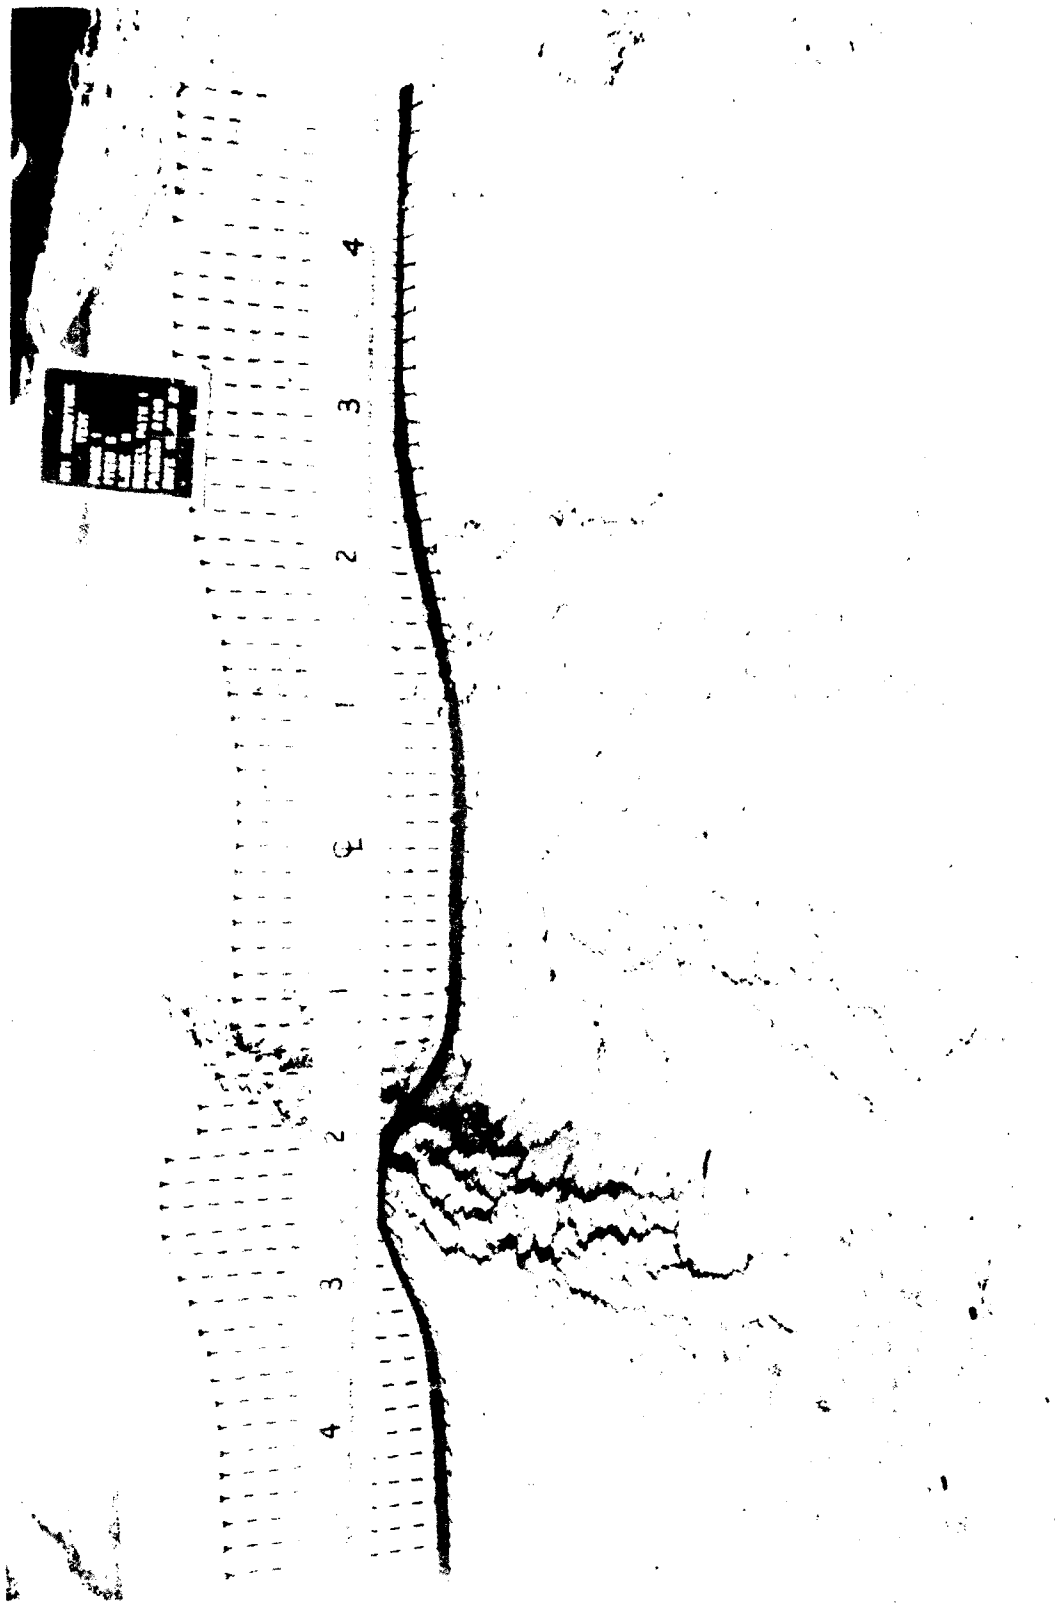
Photo 21. Item 5, wheel path 4, general view of failure after 2,076 passes

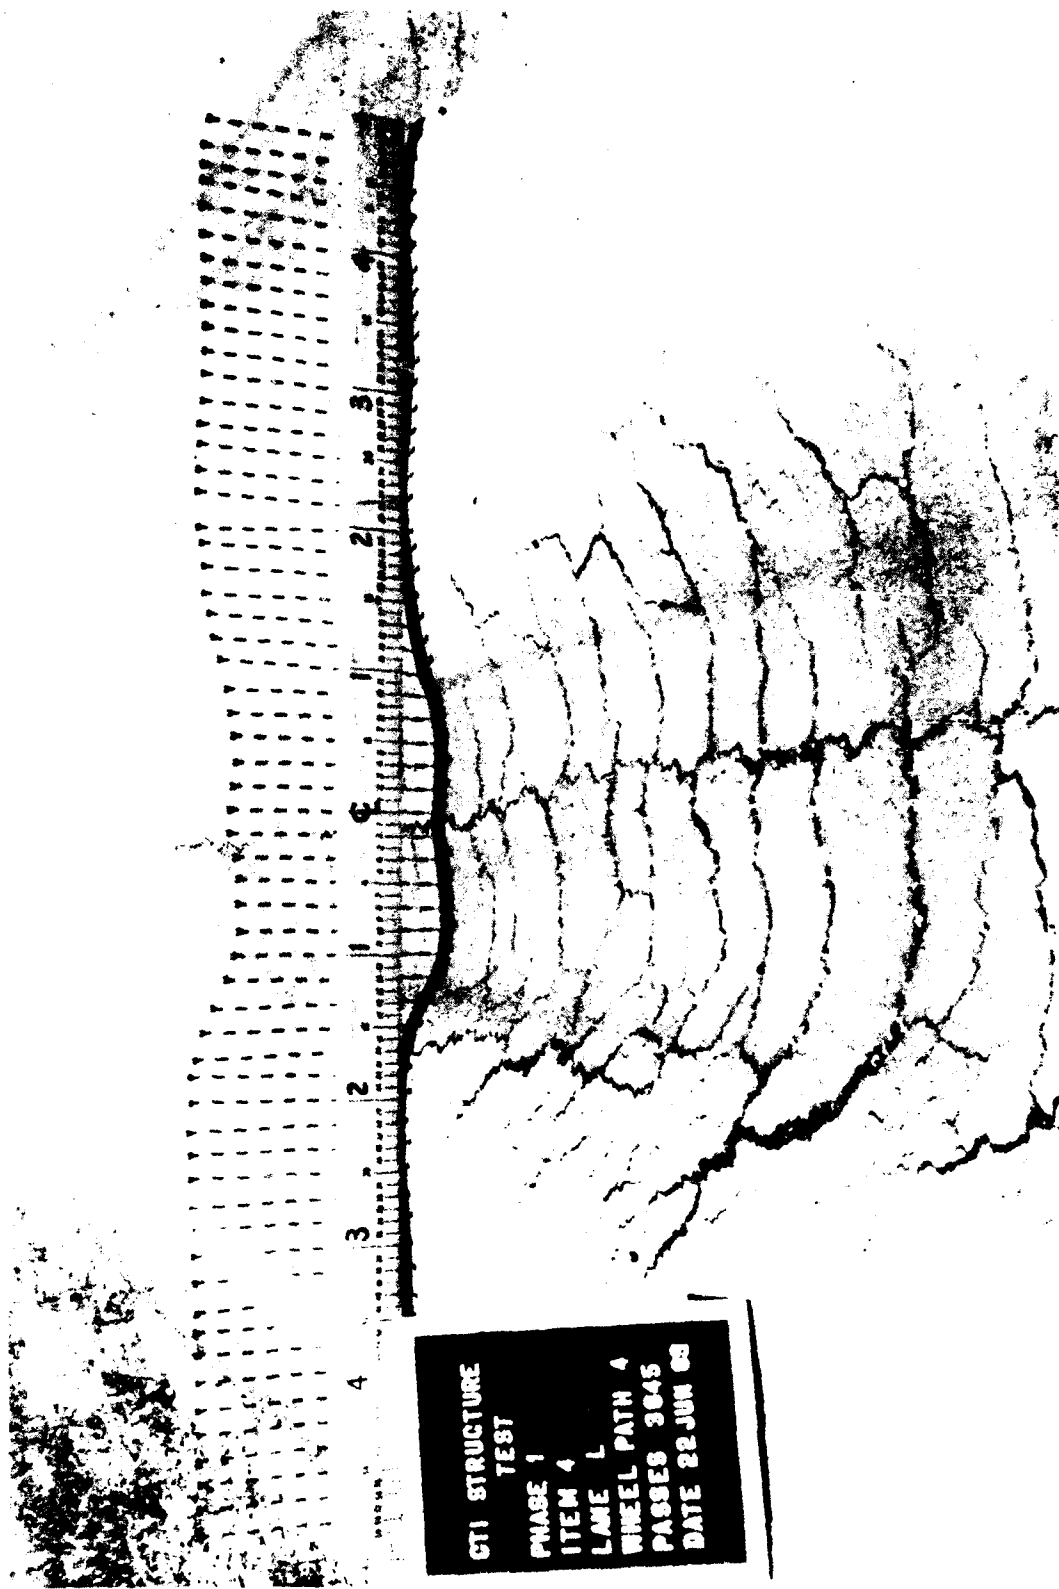
Photo 24. Item 4, wheel path 4, failure after 3,845 passes

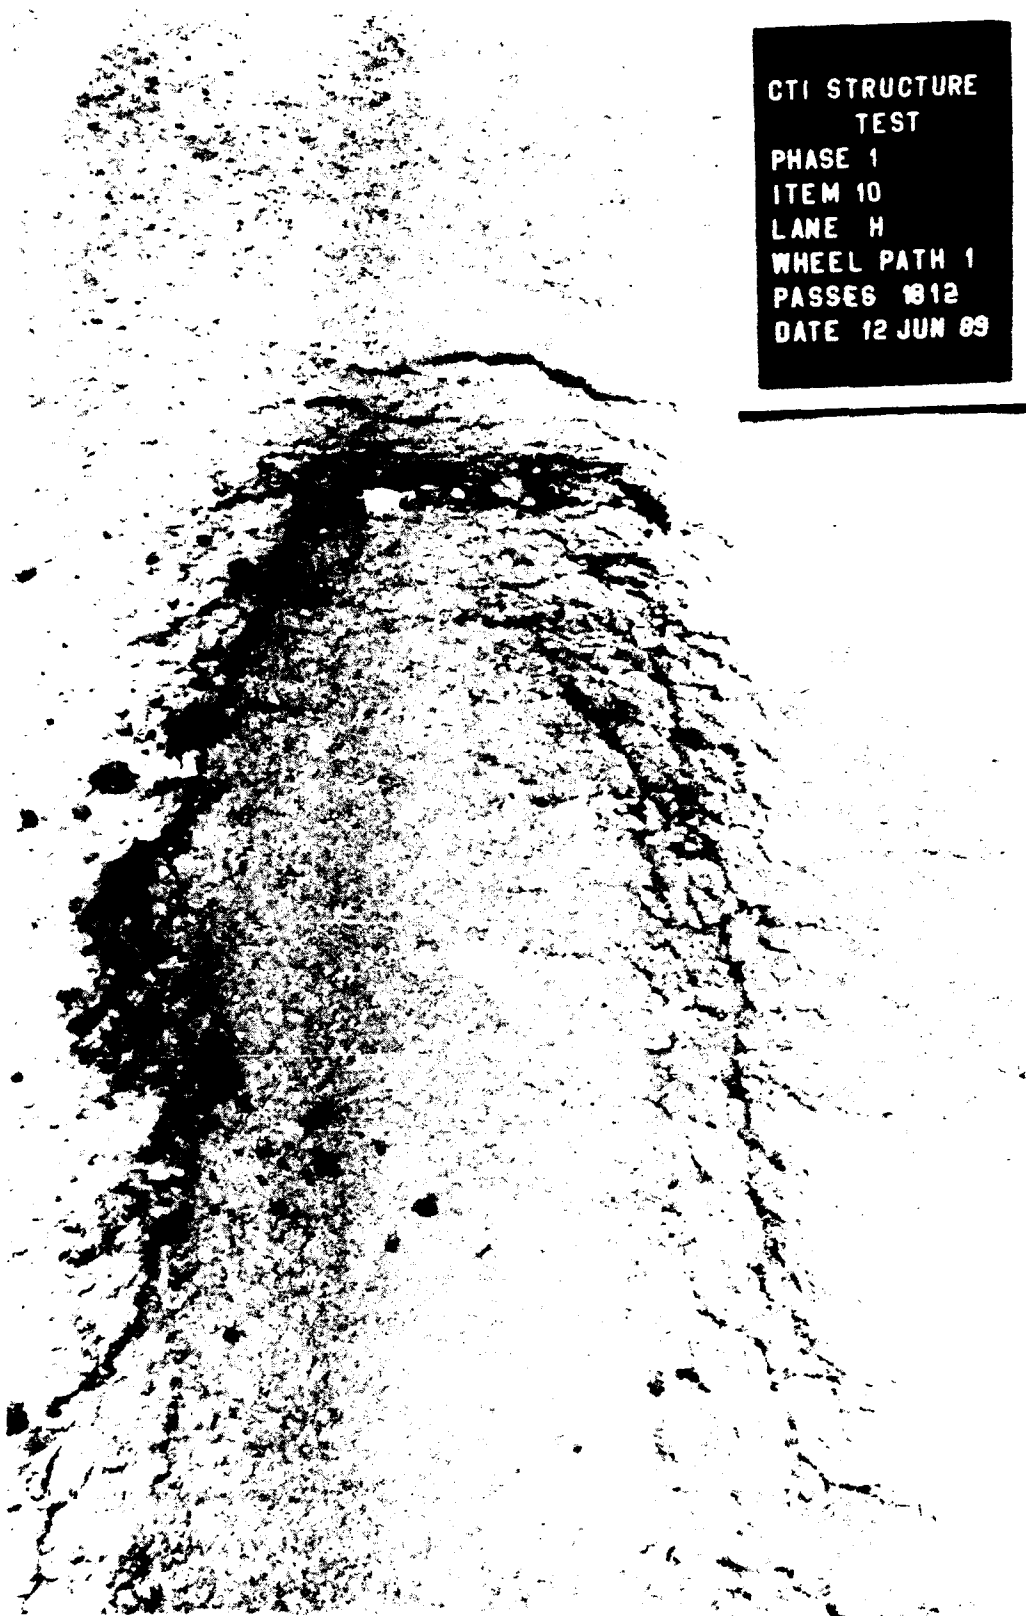
Photo 31. Item 10, wheel path 1, high-severity shoving after 1,812 passes
